Ridgeline Inspections LLC

Confidential - Property Inspection Report - Confidential

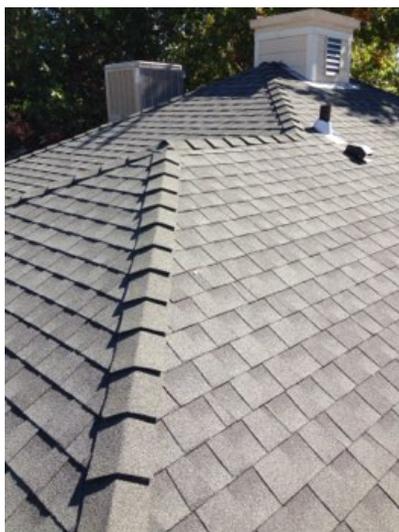
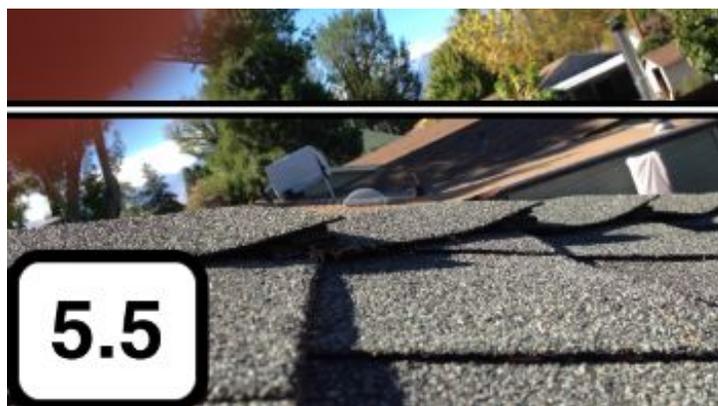
- The underlayment was hidden beneath the roof-covering material. It was not inspected and the Inspector disclaims responsibility for evaluating its condition or proper installation.

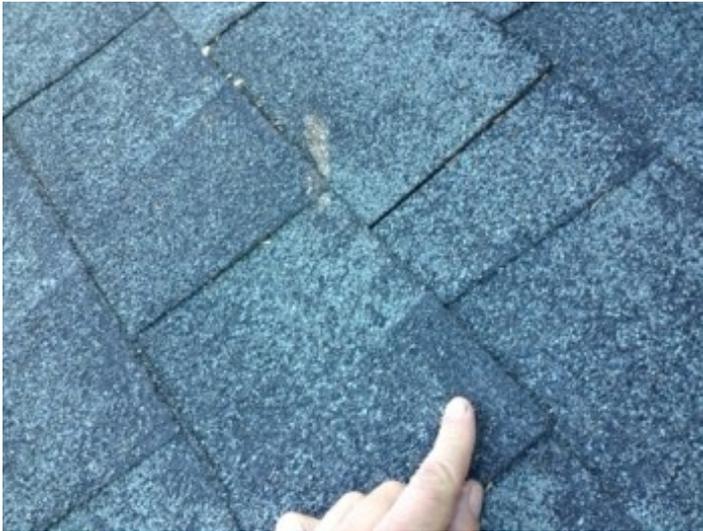
Granular deterioration

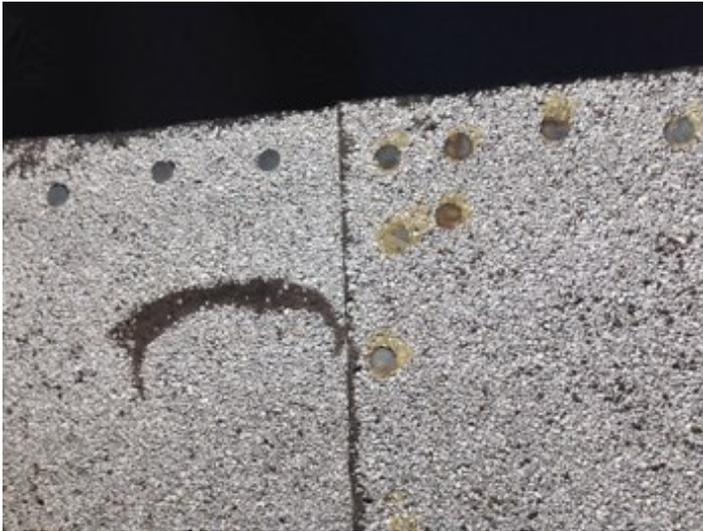
Nails on carport are not sealed

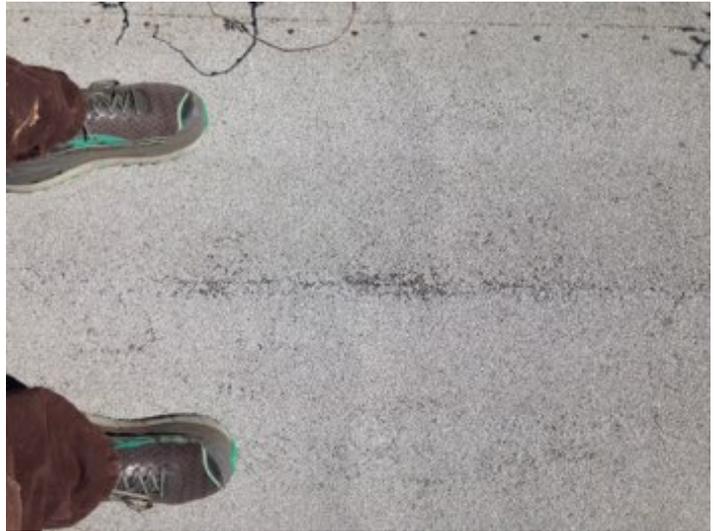
Granular deterioration at carport roof ridge

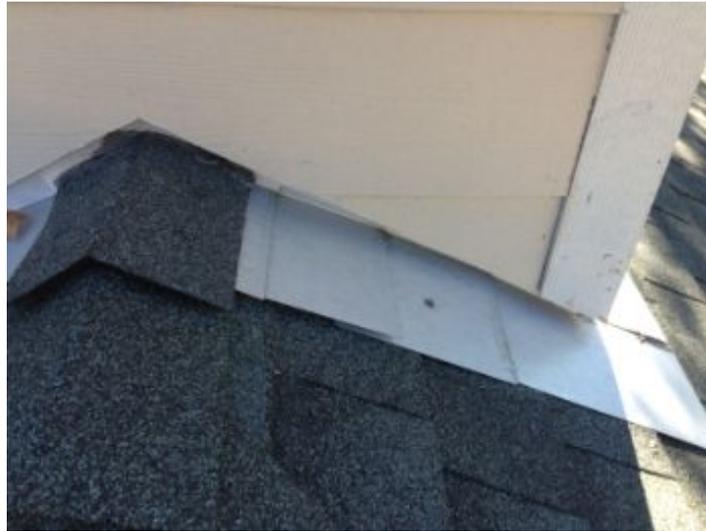
step flashing improperly installed

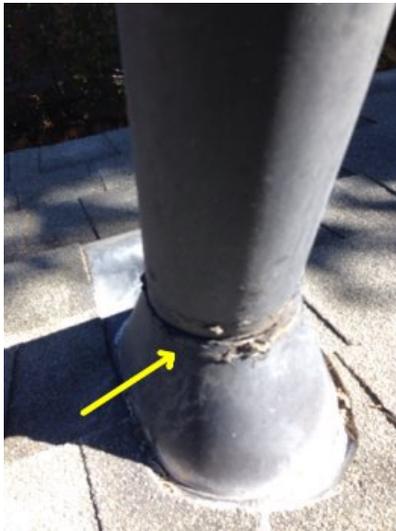
Deteriorated sealing around boot.

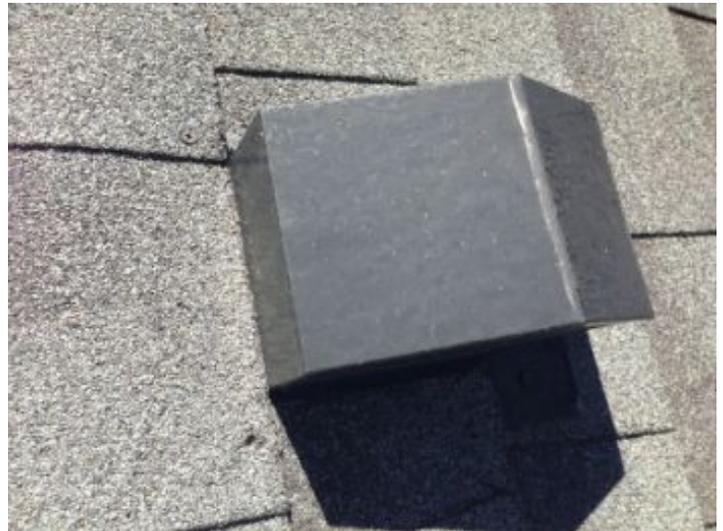
metal ventilation fan for bathroom

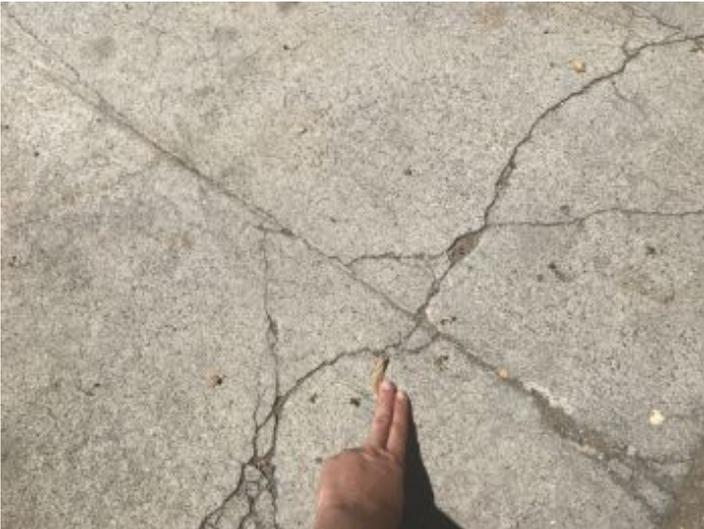
- Common cracks (1/4-inch or less) were visible in the driveway. Cracks exceeding 1/4-inch should be filled with an appropriate material to avoid continued damage to the driveway surface from freezing moisture.
- The driveway is improperly sloped towards the foundation. Moisture can build up against the foundation and cause deterioration and/or cracking, although no issues were observed at the time of the inspection. Recommend monitoring foundation annually and repairing or replacing the drive to properly slope away from the foundation if problems occur.

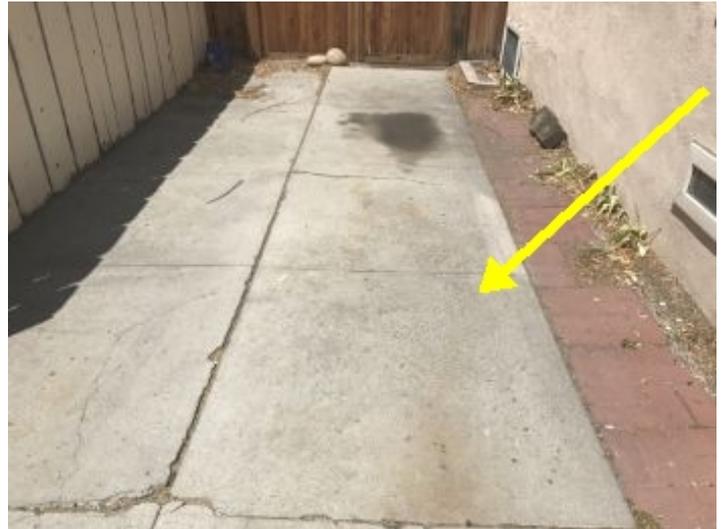
sloped toward foundation

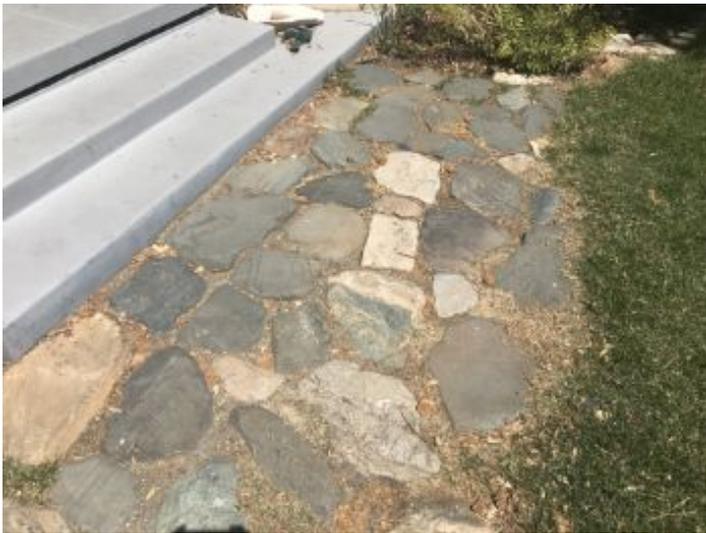
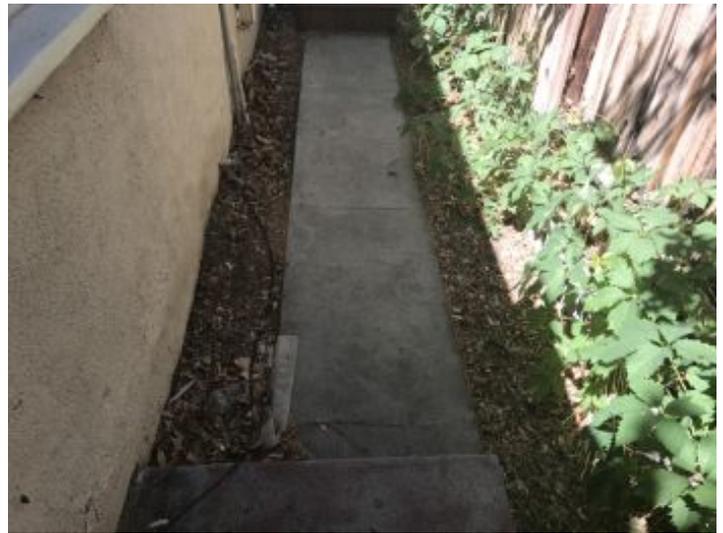
some unevenness at front flagstones may be a trip hazard to some

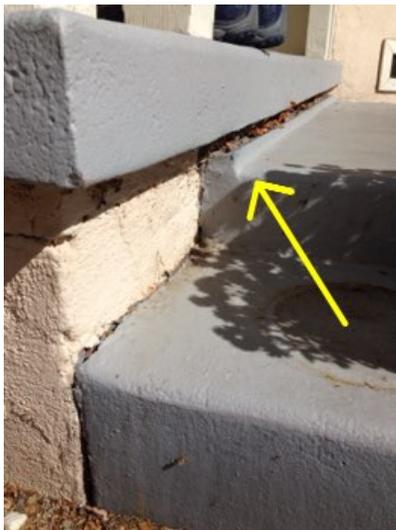
Settling of front steps

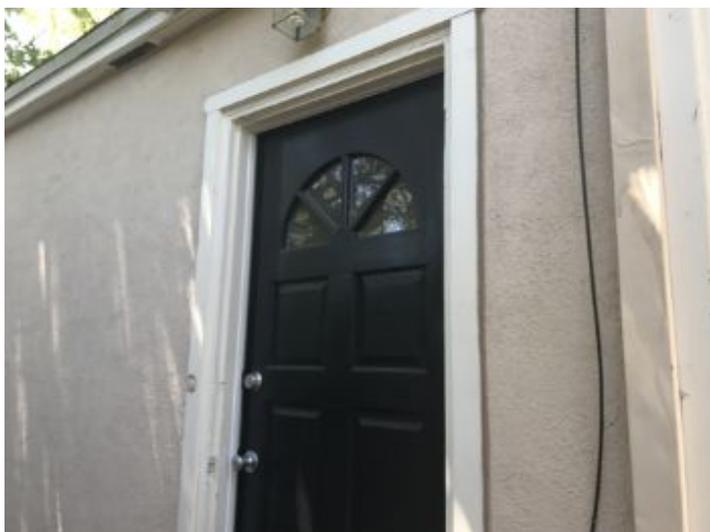
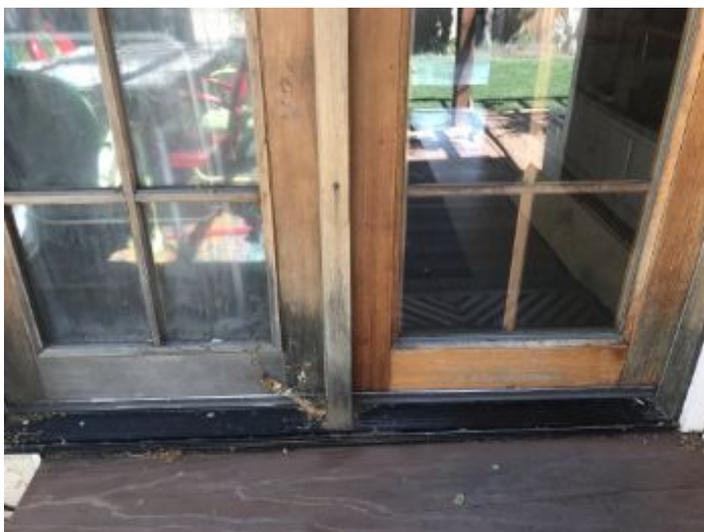
wood staining at lower portions of doors

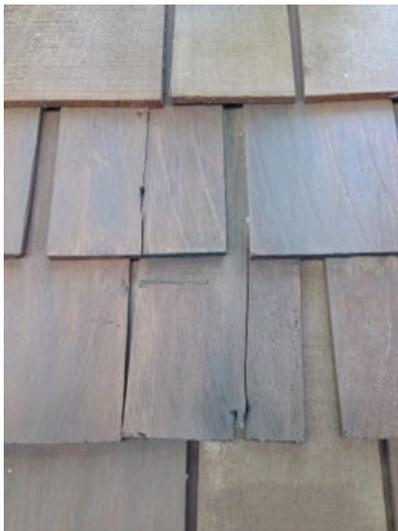
• Some wood shingles covering exterior walls were split. Splitting is typically due to age and exposure to weather and an often-used rule of thumb calls for replacement when 30% or greater of shingles are split. The percentage of split shingles covering exterior walls appeared to be lower than 30% at the time of the inspection.

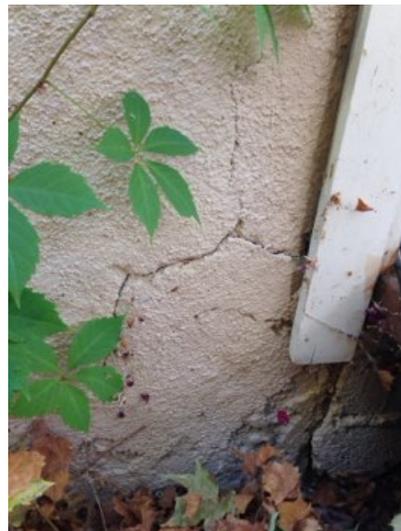
Minor cracking in NE corner.

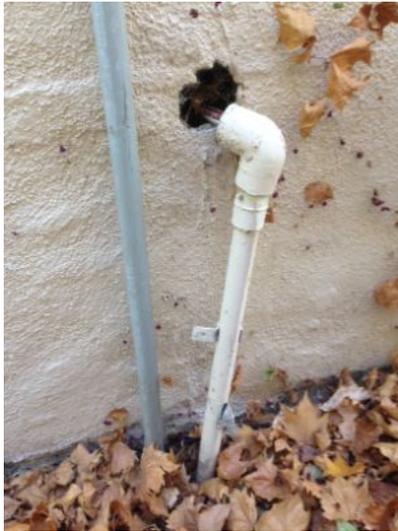
Irrigation conduit is loose and needs securing and sealing.

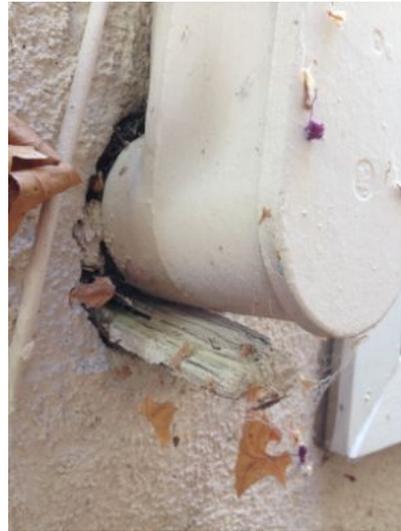
Electrical conduit needs sealing. Note the piece of wood filling the gap.

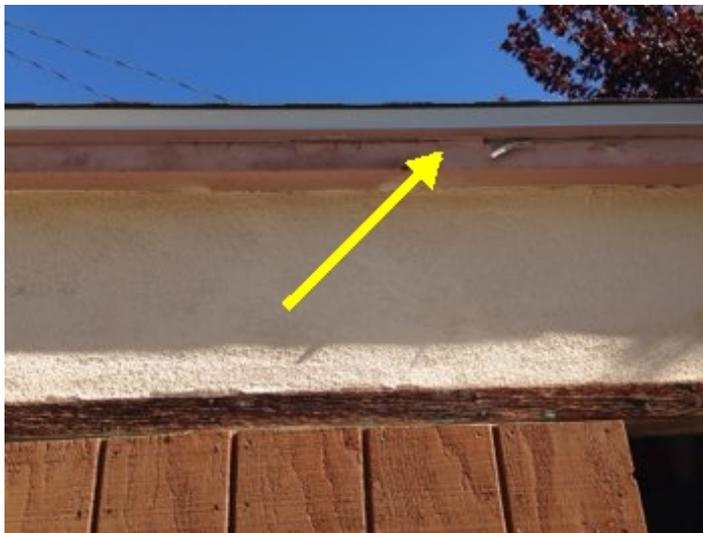
Peeling paint on Garage fascia.

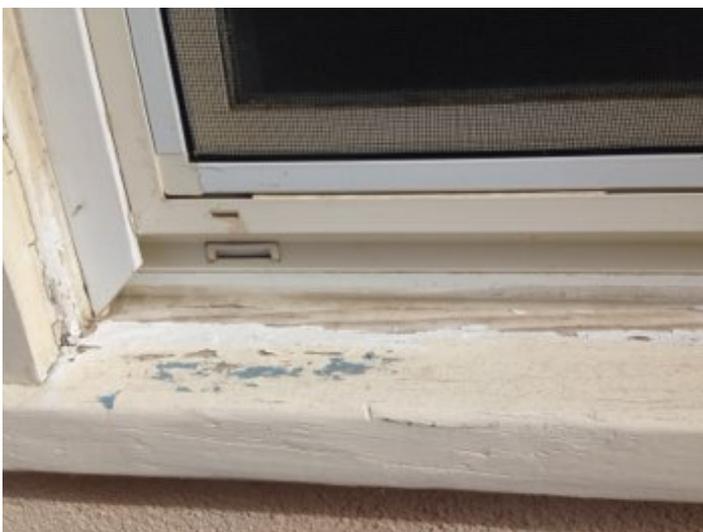
Peeling paint around some windows at trim.

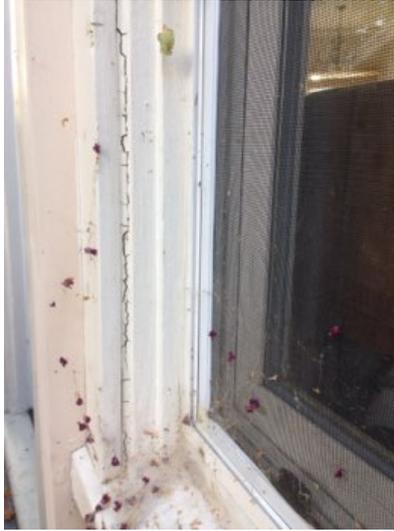
Cracked caulking around some windows

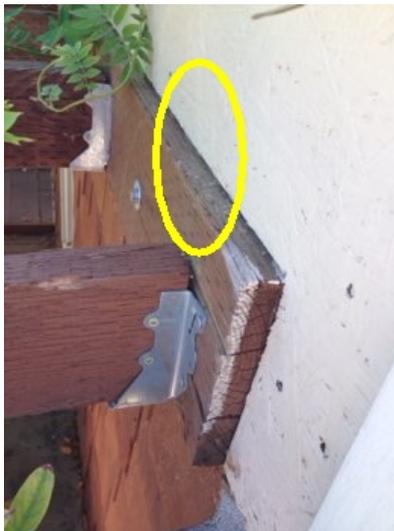
Top of pergola ledger board.

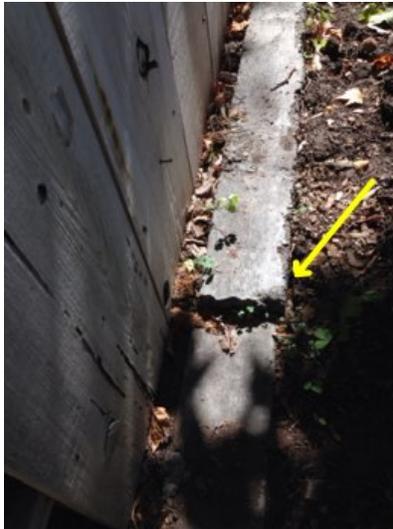
Cracked retaining wall.

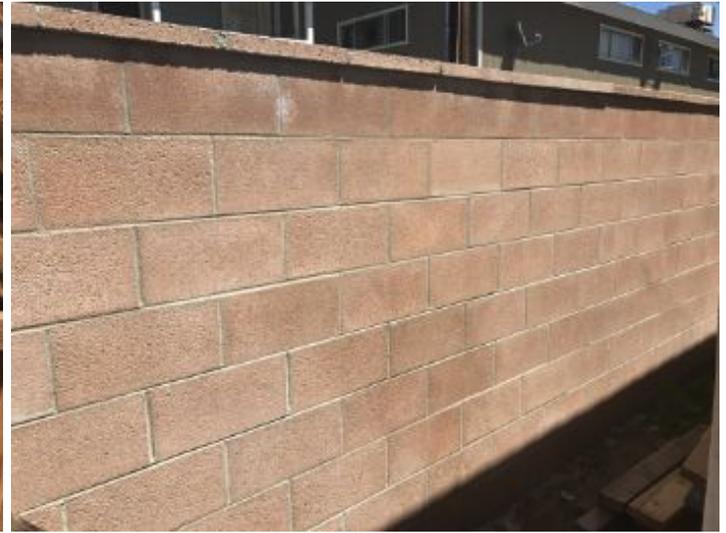
wall along back alley

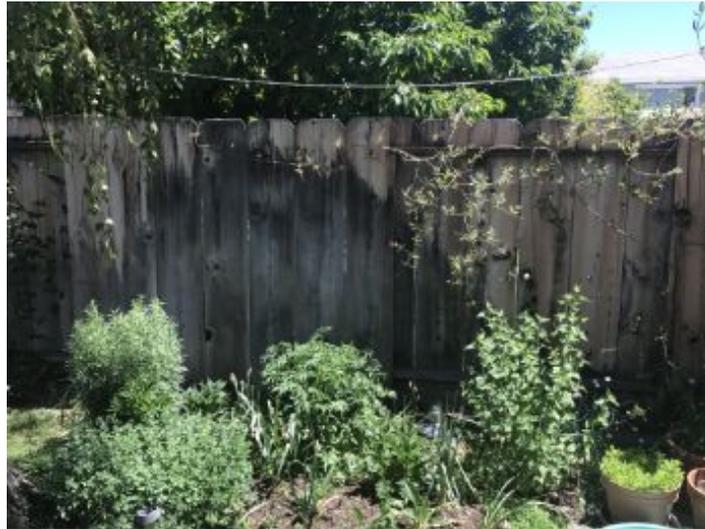
fencing showing water stains

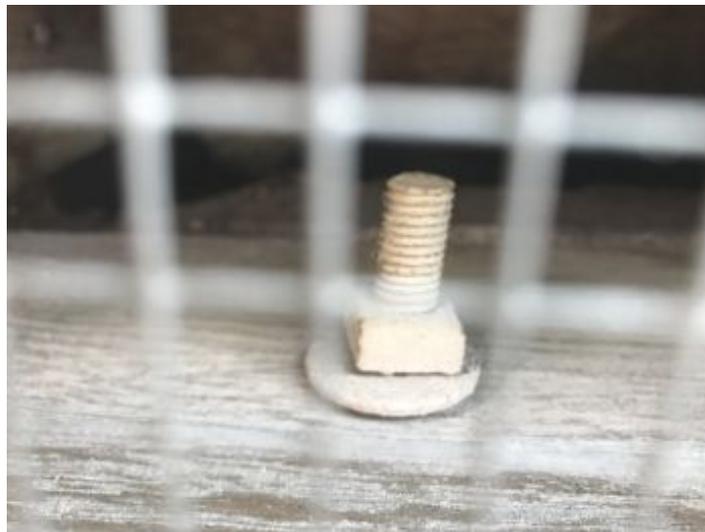
- Limited review of unfinished area due to insulation cover.
- The visible portions of the foundations walls consisted of poured concrete.
- Rigid insulation covered most of the foundation walls, but one anchor bolt was observed at the West rear vent opening, indicating that the structure is likely bolted to the foundation. Anchor bolts are designed to attach the home structure to the foundation.

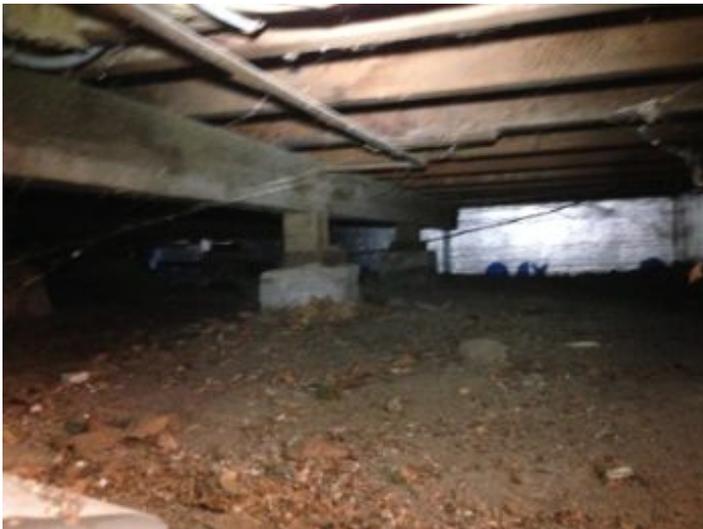
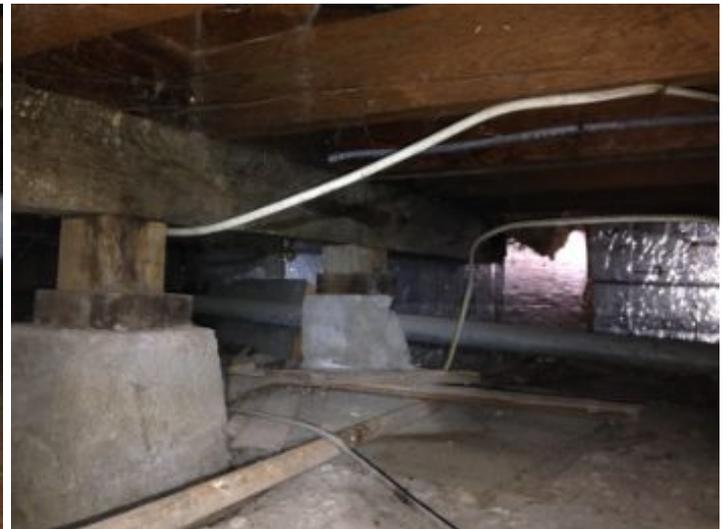
Crawlspace image showing dirt floor, rigid insulation along foundation walls, and abandoned plumbing and trash on floor

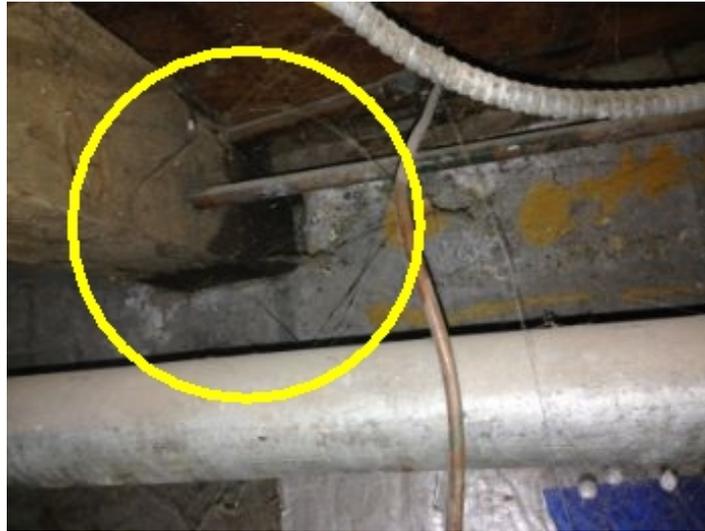
Moisture evident on beam at front of house.

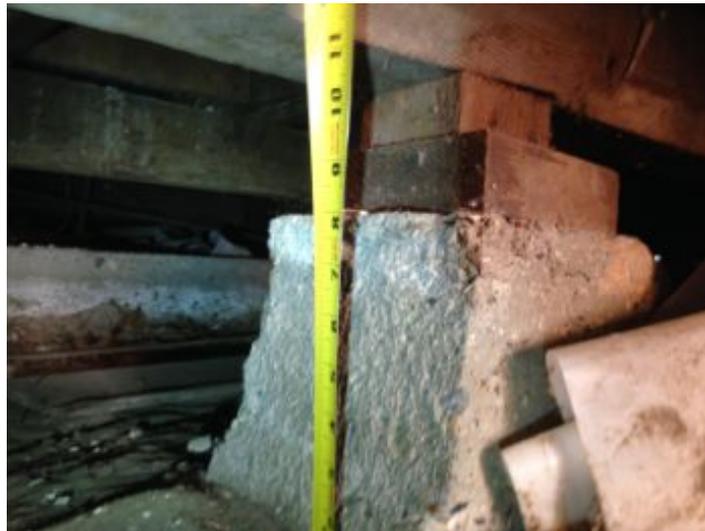
concrete blocks and wood blocks

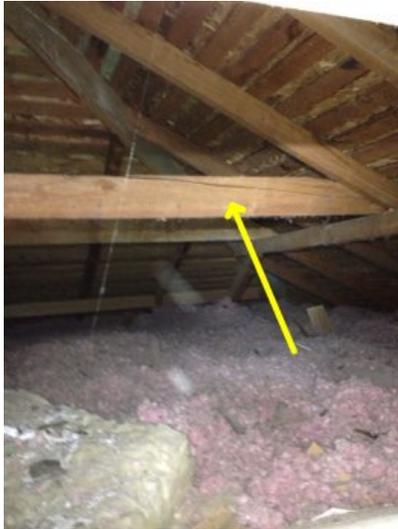
Split rafter tie in attic.

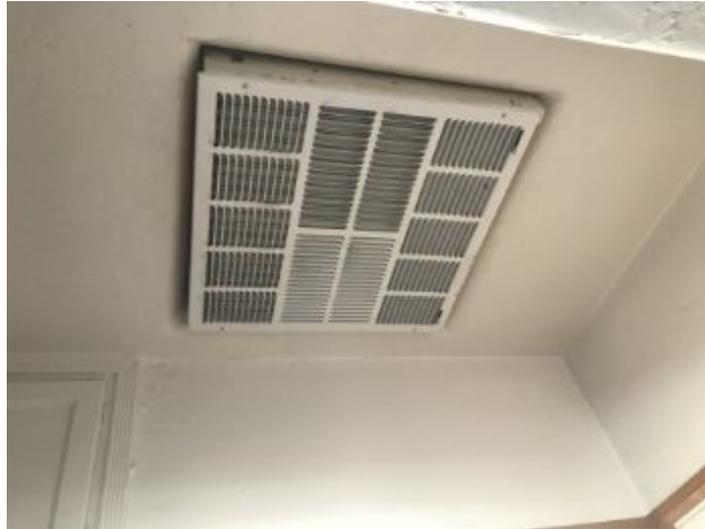
Access through evap cooler opening--push up and aside

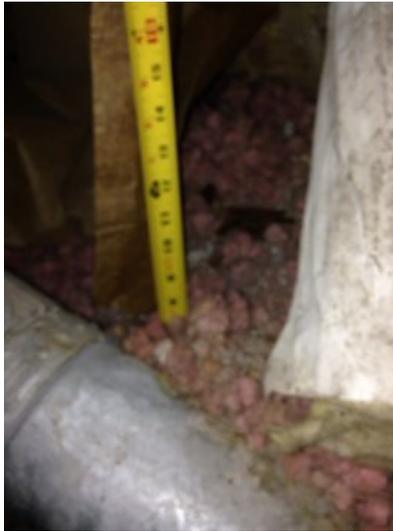
Insulation depth was 9 - 12 inches.

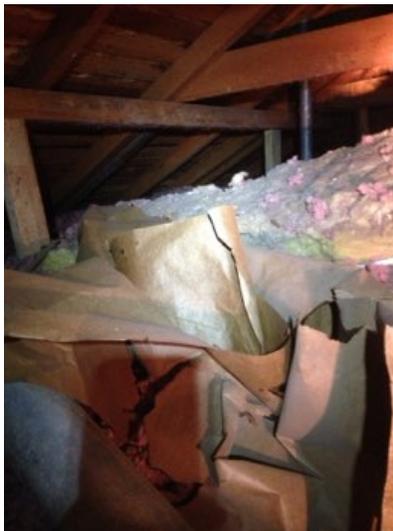
Some trash and piled up insulation batts were present in attic.

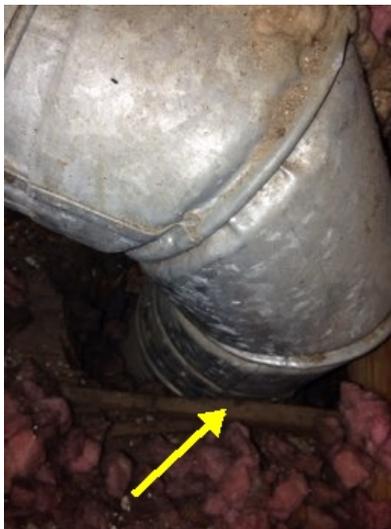
Type b gas vent too close to combustible materials.

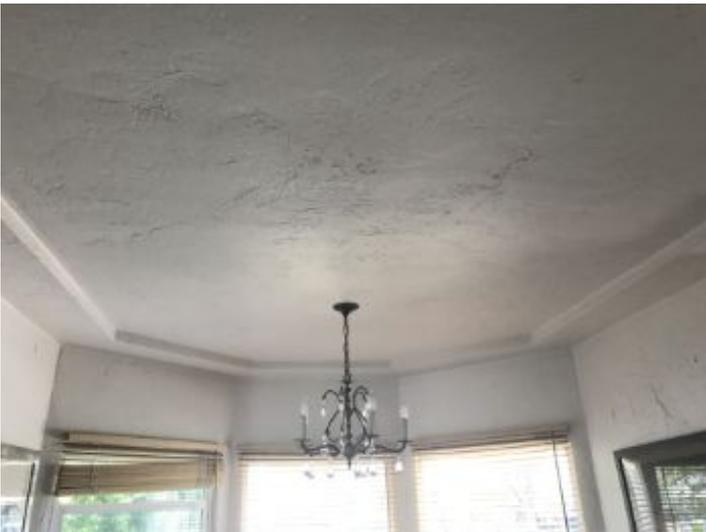
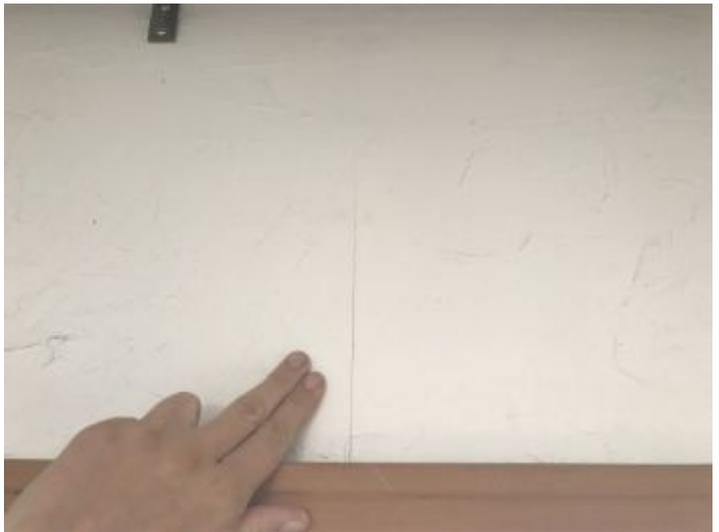
- At the time of the inspection, the Inspector observed few deficiencies in the condition of ceilings and walls in the home. Notable exceptions will be listed in the appropriate place n this report.
- Some cosmetic, common small cracks and typical flaws in ceiling noted. This is normal wear for age of home.

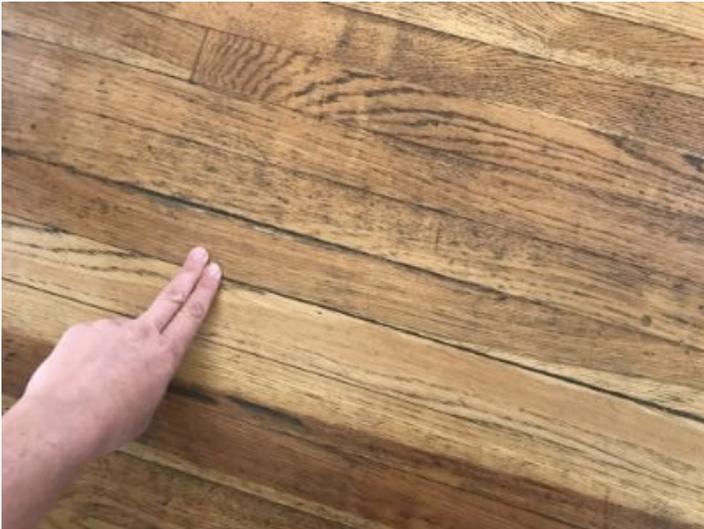
- At the time of the inspection, the Inspector observed few deficiencies in the condition of most floors in the home. Notable exceptions will be listed in this report.
- Wood floors exhibited moderate squeaking at the time of the inspection. This is usually due to fastener movement and can be difficult to correct because the flooring is fastened as it is installed in such a manner that fasteners are not visible or accessible once installation is complete.
- **IMPROVE:** Wood floors moderately worn in several areas. refinishing floors will extend their lifetime.

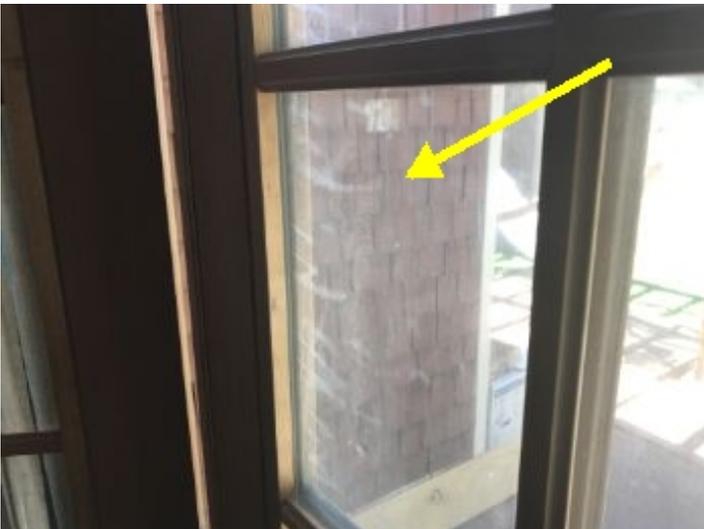
cloudiness on rear window

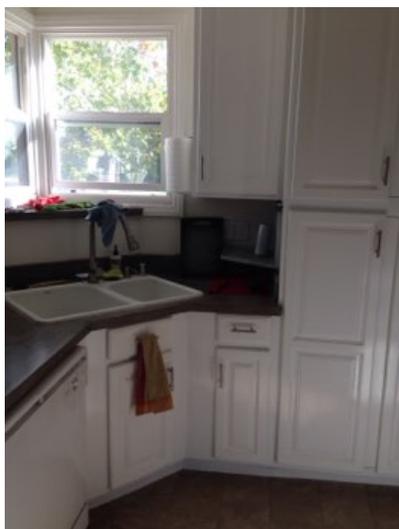
Kitchen cabinets and countertops.

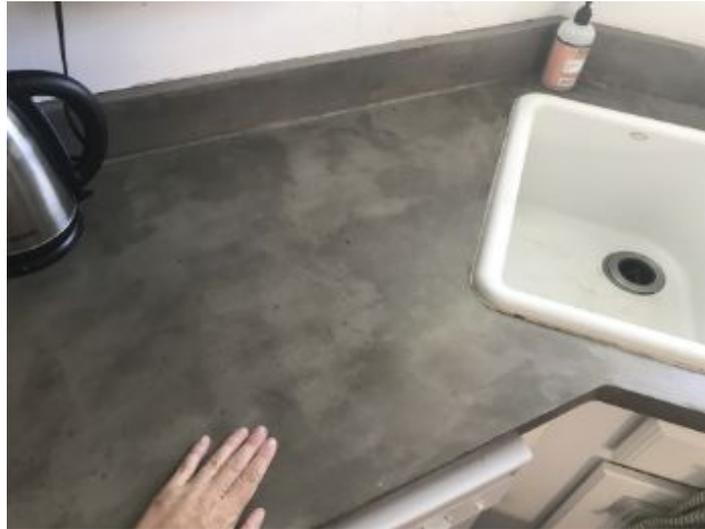
- At the time of the inspection, the Inspector observed few deficiencies in the condition of the kitchen countertops. Notable exceptions will be listed in this report.

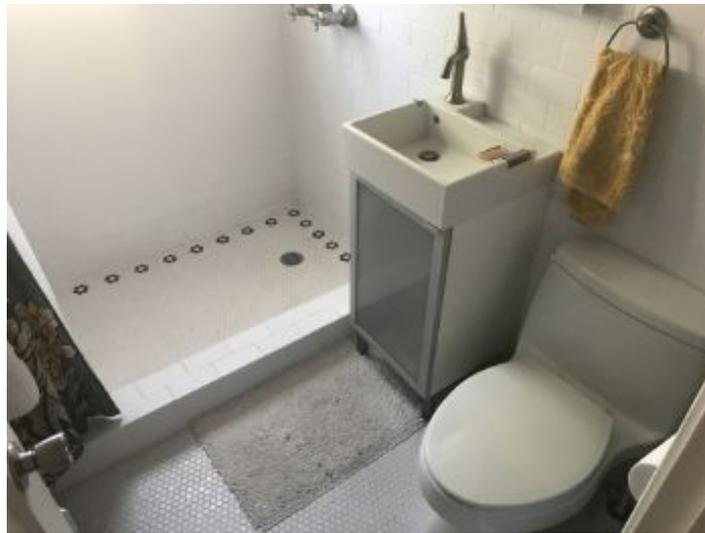
2. General Condition

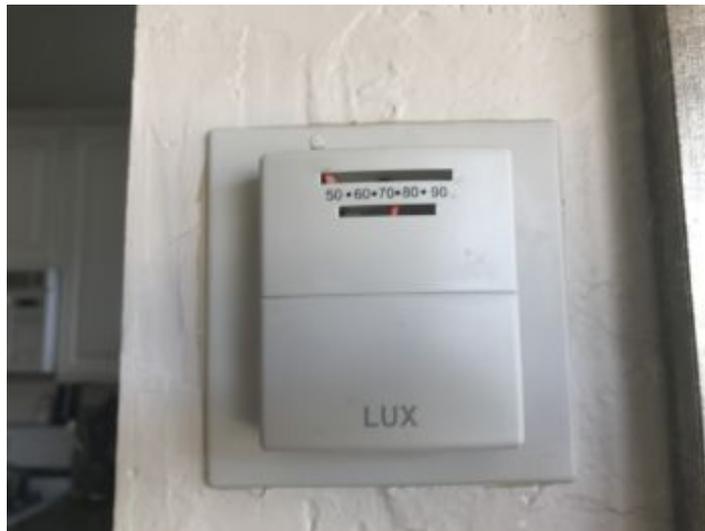
- No deficiencies noted.
- **IMPROVE:** Non-programmable thermostats have no energy saving capabilities as do digital setback-type thermostats. Recommend an upgrade to a modern, digital programmable thermostat. This could yield a savings in energy costs.

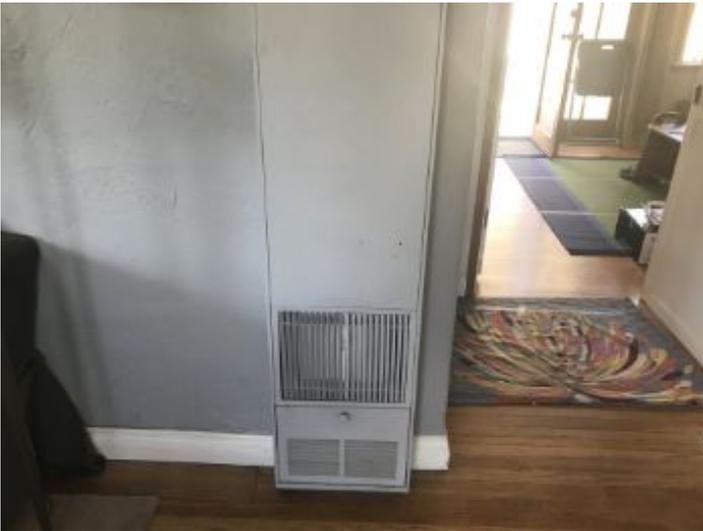
lower portion or wall heater

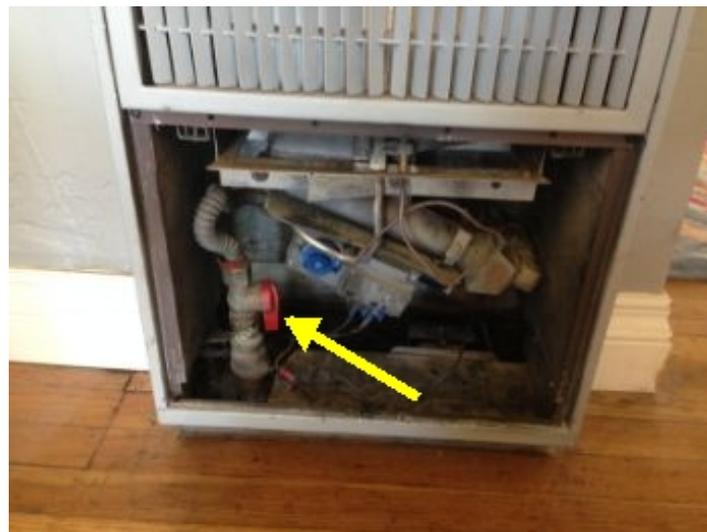
gas shut-off. Note lack of drip leg (addressed in #2 Energy Source)

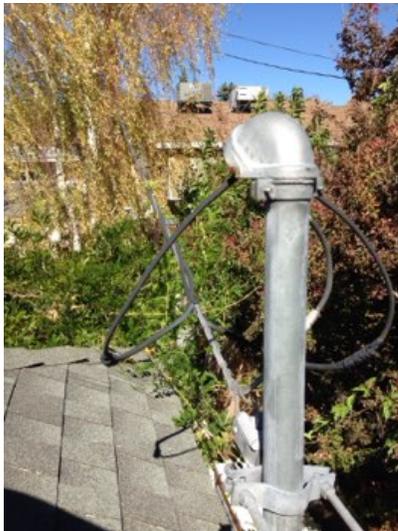
Service line running through trees.

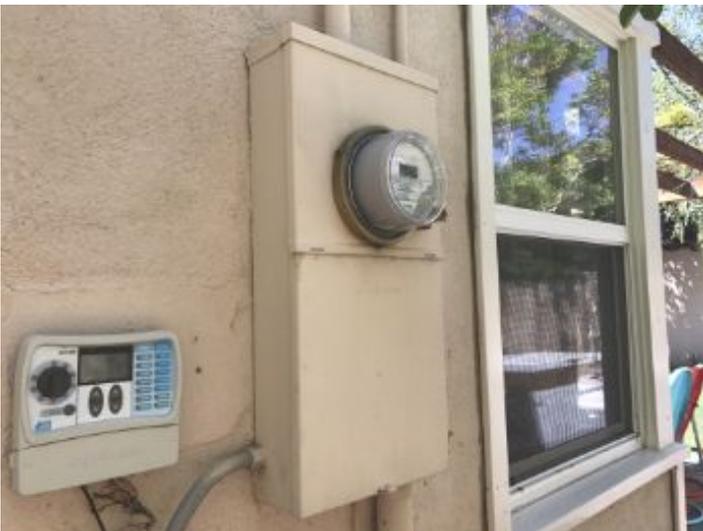
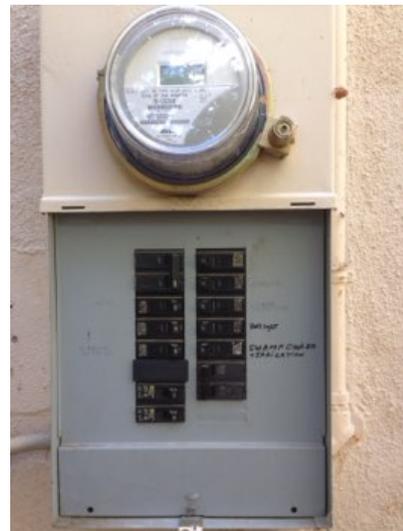
7. Service Panel Cabinet and Dead Front Cover

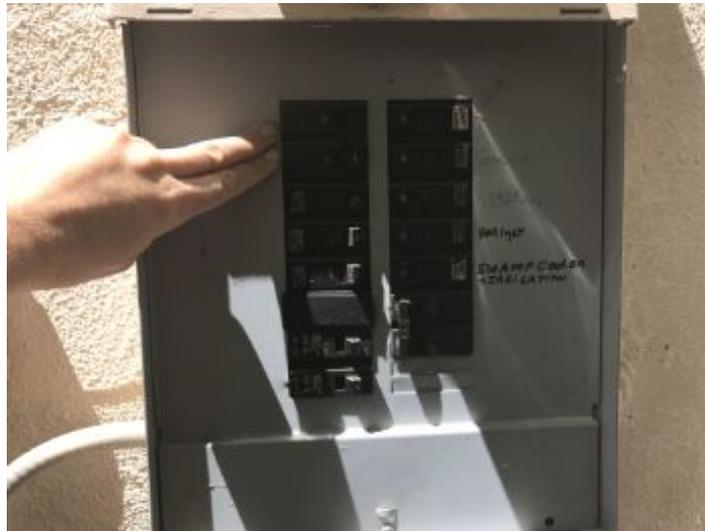
10. Equipment Grounding and Bonding

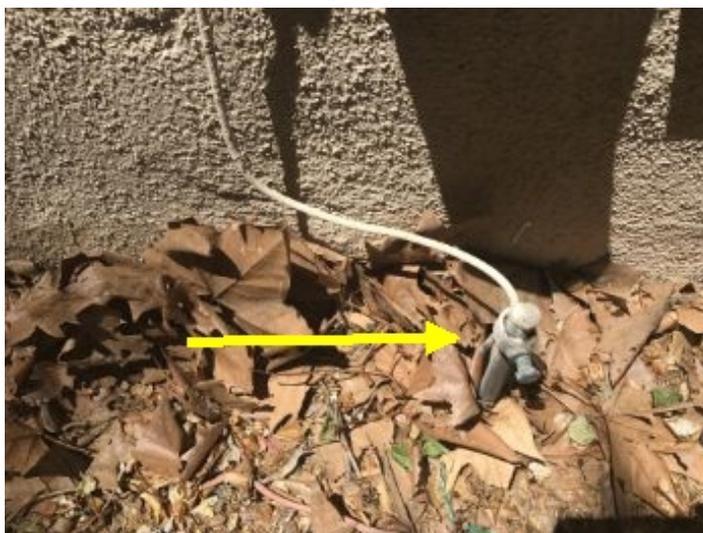
12. Overcurrent Protection

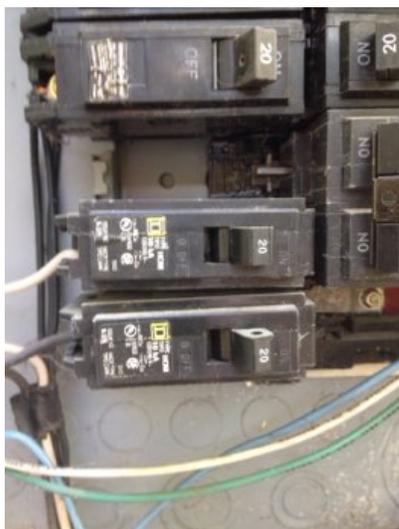
- In the service panel, two wires were connected to a breaker designed for only one wire. This is known as a "double-tap" and is a defective condition. The Inspector recommends correction by a qualified electrical contractor.

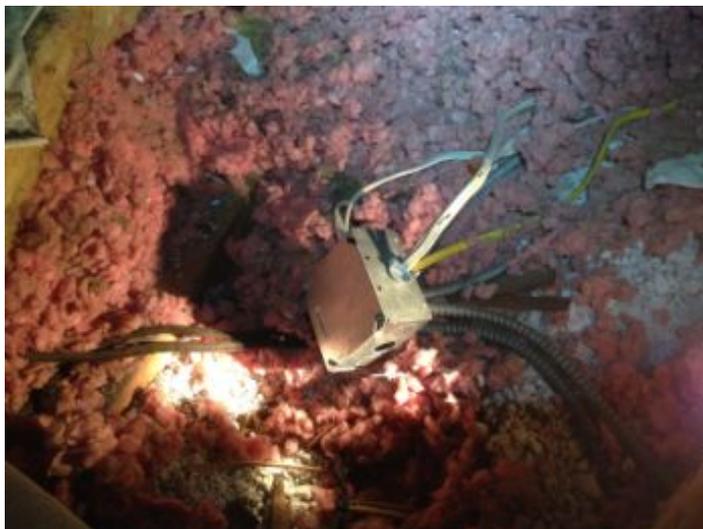
Junction box not secured to framing and featuring too many conductors

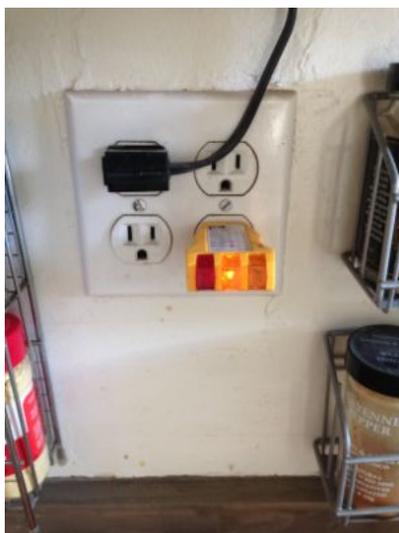
open ground at kitchen counter

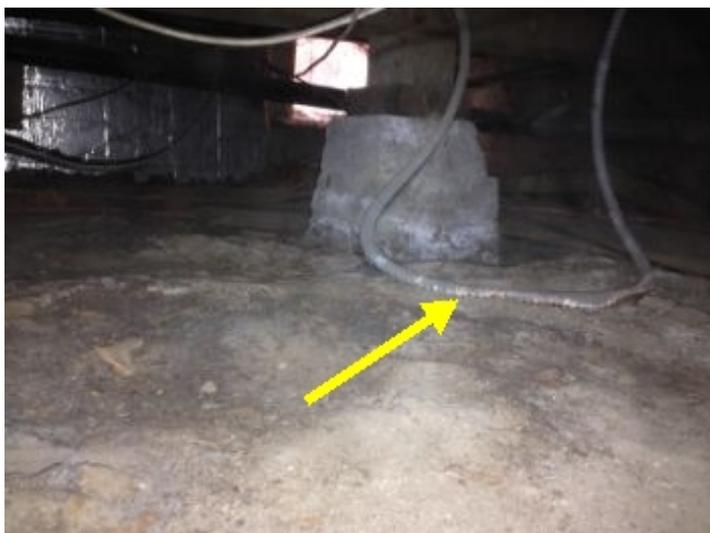
Electrical conduit on crawspace floor

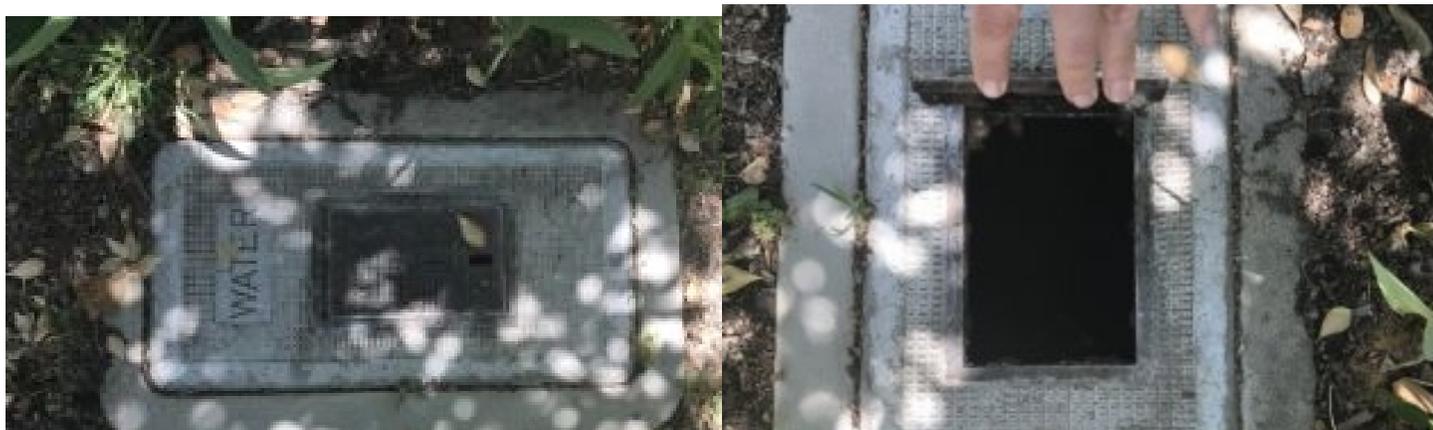
- At the time of the inspection, the Inspector observed no deficiencies in the condition of the main water supply shut-off valve. It was not operated but was visually inspected.

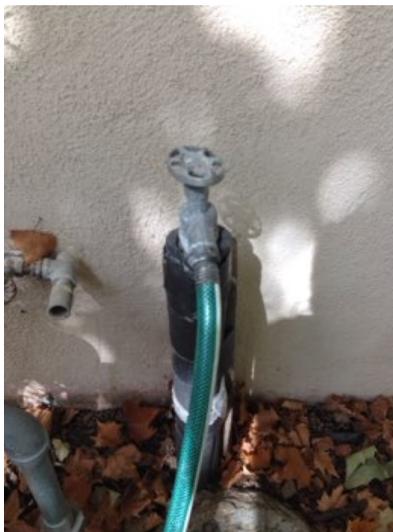
South exterior hose bib.

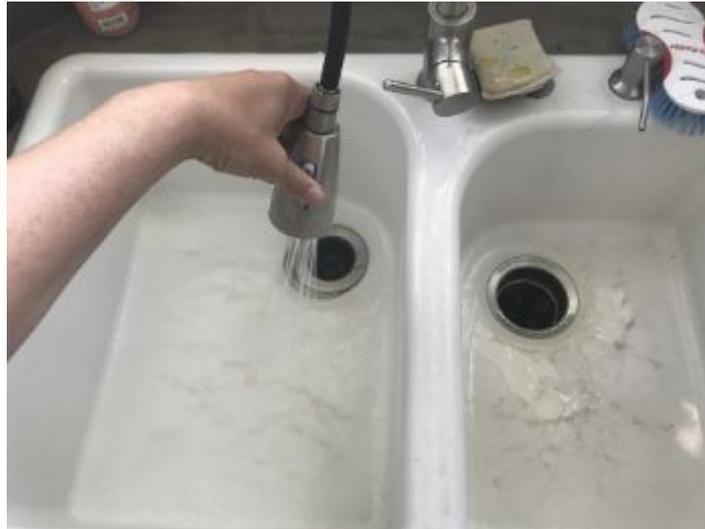
- The kitchen sink faucet appeared to be in serviceable condition at the time of the inspection.
- The bathroom sink faucet appeared to be in serviceable condition at the time of the inspection.

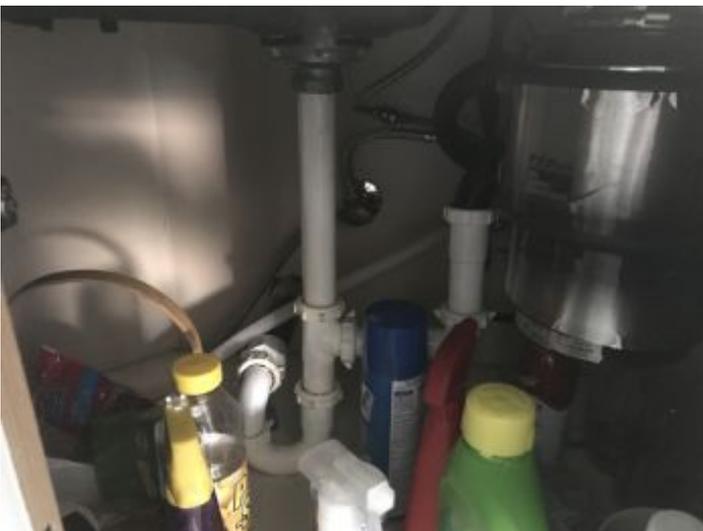
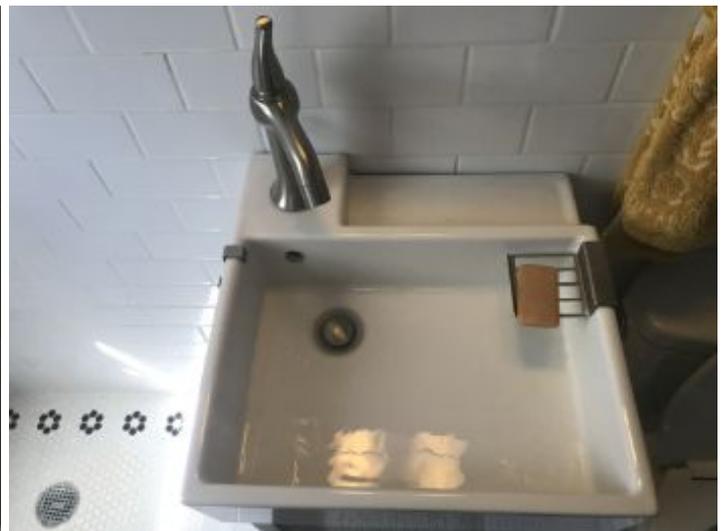
- At the time of the inspection, the Inspector observed no deficiencies in the condition and operation of the kitchen sink.
- At the time of the inspection, the Inspector observed no deficiencies in the condition and operation of undersink plumbing in the kitchen.
- This bathroom sink was slow to drain. If drain openers do not help, the Inspector recommends the blockage be located and cleared by a qualified plumbing contractor.

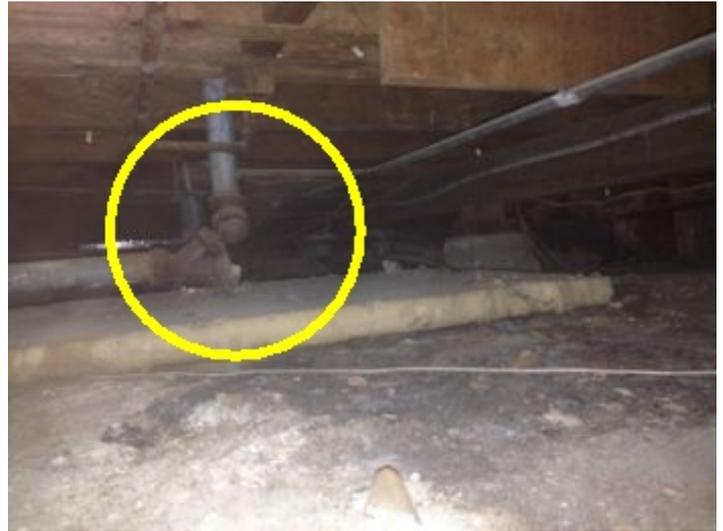
disconnected waste piping appears to be abandoned

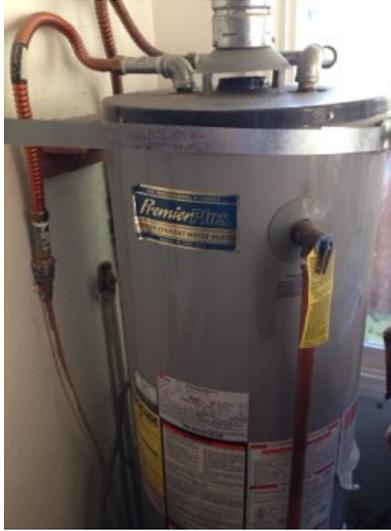
American Water Heater

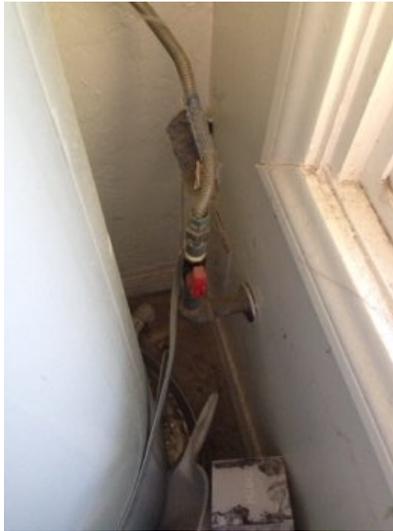
FYI: Gas shutoff located behind tank.

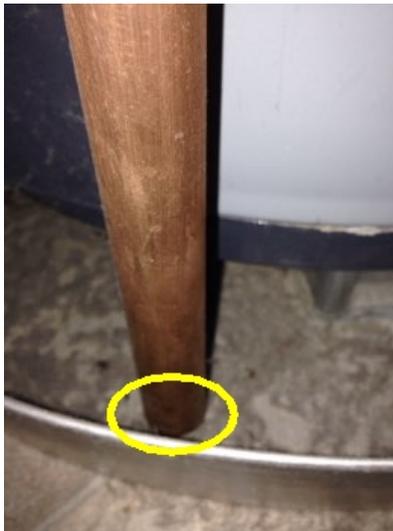
TPR discharge needs air gap.

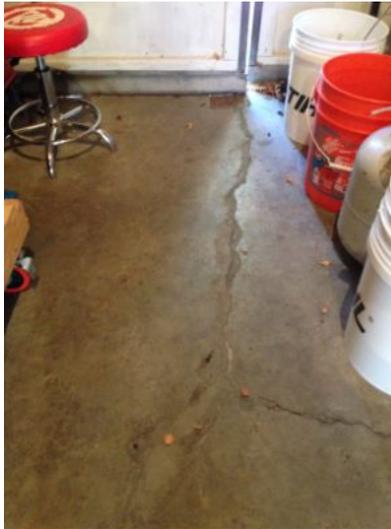
Cracking in garage floor

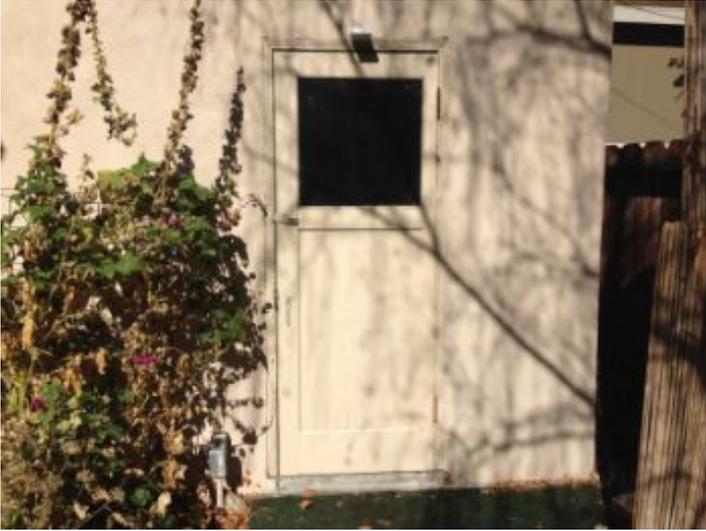
Garage exterior door

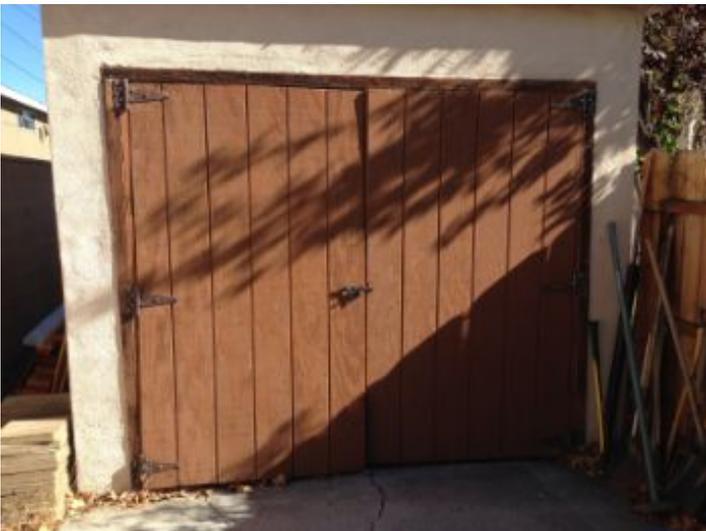
• Doors were warped and did not close thoroughly, leaving a gap in some areas. Door hinge has come detached in lower left corner. Possibly due to poor wood frame condition to which it was attached. This puts added stress from a heavy door on the remaining hinges. For safety reasons, the Inspector recommends correction or replacement by qualified individual.
