Ridgeline Inspections LLC

Confidential - Property Inspection Report - Confidential

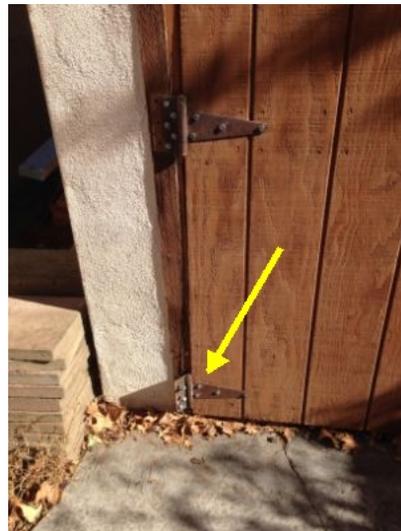
Loose hinge at lower left of garage door.
